# ESD PROTECTION TO OVERCOME INTERNAL GATE-OXIDE DAMAGE ON DIGITAL-ANALOG INTERFACE OF MIXED-MODE CMOS IC's

**Abstract:** This paper reports an ESD internal gate-oxide damage occurred on the digital-analog interface of a mixed-mode CMOS IC. A new ESD protection method is proposed to rescue this internal gate-oxide damage by adding ESD-protection devices on the long metal line between digital-analog interfaces. Experimental verification has confirmed that the IC product can be rescued to pass 2-KV ESD stress from the digital/analog VDD to digital/analog VSS pads without causing any internal damage again.

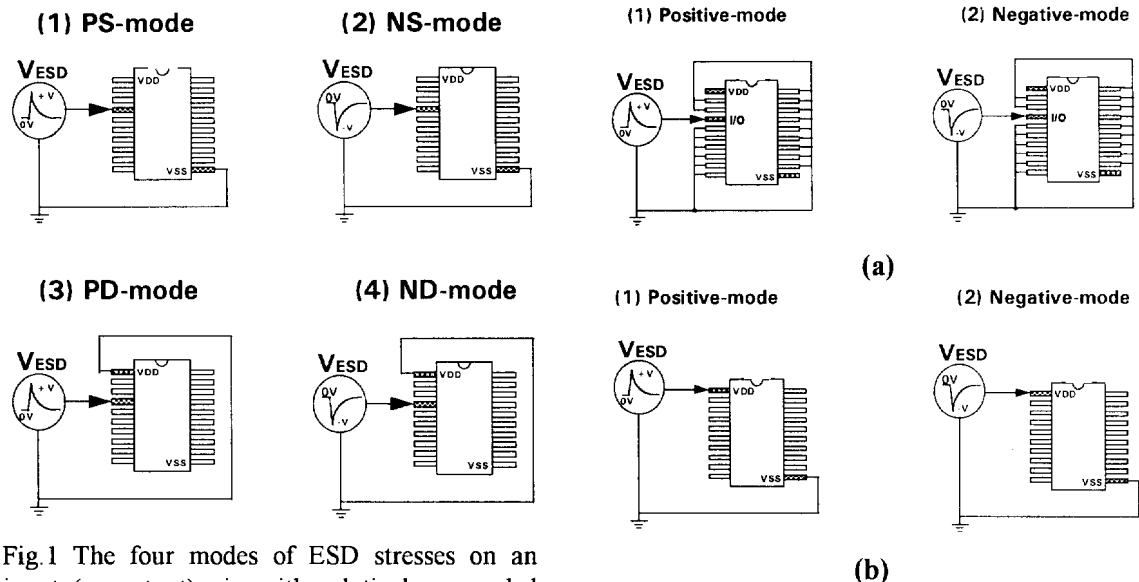
Fig.1 The four modes of ESD stresses on an input (or output) pin with relatively grounded VDD or VSS pins.

Fig.2 Two additional ESD-testing conditions to verify the whole-chip ESD reliability.

Since an ESD stress may have positive or negative voltage polarity on an input (or output) pin with reference to grounded VDD or VSS pins, there are four different ESD-stress modes on an input (or output) pin [5]. The four modes of ESD stresses on an input (or output) pin are illustrated in Fig.1. Moreover, ESD current could enter into any pin and go out from another pin of an IC. To practically verify the whole-chip ESD reliability, two additional testing conditions have to be considered into the ESD testing [6]. These two additional ESD testing conditions are shown in Figs.2 (a) and 2(b). In Fig.2(a), the ESD voltage is stressed on an input (or output) pin as other input and output pins are grounded but both the VDD and VSS pins are floating. In

Fig.2(b), the ESD voltage is directly stressed on the VDD pin with grounded VSS pin but all input and output pins are floating. In these two ESD testing conditions, the CMOS IC's are more vulnerable to internal ESD damage even if there are input and output ESD protection circuits on the input and output pads.

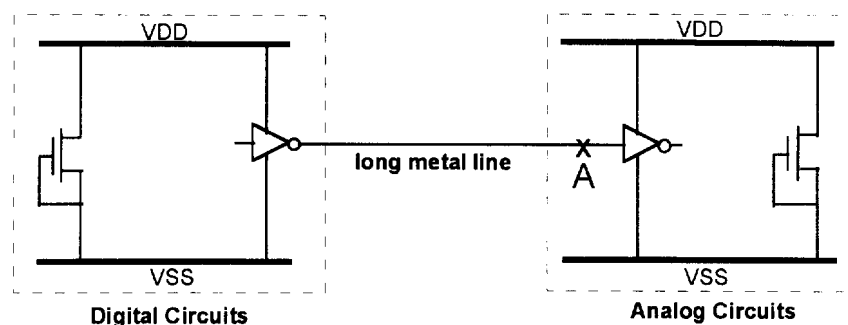
The schematic circuit diagram of a mixed-mode IC in our case is shown in Fig.3, where the input of inverter in the analog part is from the output of digital part with a long metal line. The VDD and VSS pads of the analog part are separated from those of the digital part. There is a gate-grounded thin-oxide NMOS device made as VDD-to-VSS ESD protection device between the digital VDD and digital VSS power lines. Between the analog VDD and VSS power lines, there is also a gate-grounded thin-oxide NMOS device made as VDD-to-VSS ESD protection device. Under the human-body-model (HBM) PS-mode ESD stress, a positive ESD voltage applied to the pad with VSS pad grounded, the input and output pads of the mixed-mode IC can sustain above 4 KV without causing any damage on the input, output, and the internal circuits. But, if a 2-KV positive ESD stress is applied to both the digital VDD and analog VDD pads with both digital VSS and analog VSS grounded, several output functions are failed. By tracing the data-process circuits and operation-control circuits, the failure is focused between the digital-analog interfaces.

Fig.3 A schematic diagram of the digital-analog interface in a mixed-mode IC.

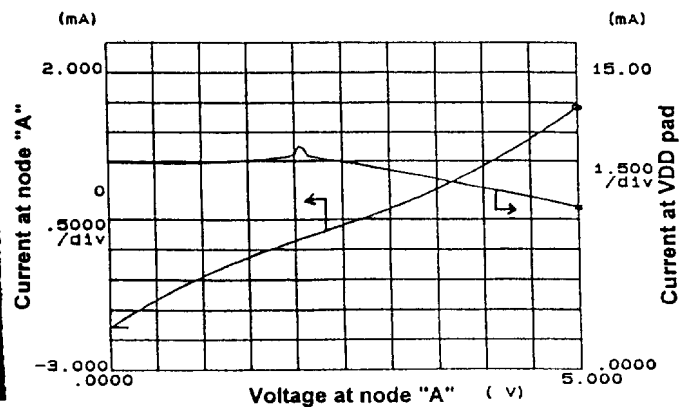
Fig.5 The measured leakage current on the input gates of analog inverter.

To point out the failure location, the photo-emission microscope (EMMI) is used to find the hot spot on the digital-analog interfaces. The measured EMMI picture is shown in Fig.4, where the failure spots are located around the input gates of an analog inverter. To verify the failure is due to gate-oxide damage, the long metal line from the digital part is cut at the "A" point in Fig.3 by a laser cutter, and internal probing technique is used to measure the leakage current at the point "A" with 5-V VDD and 0-V VSS biases. The measured result is shown in Fig.5, where there is about 2-mA leakage current on the gates of PMOS and NMOS devices of the analog inverter. This confirms that the positive ESD stress from the VDD to VSS causes internal gate-oxide damage between the digital-analog interfaces.

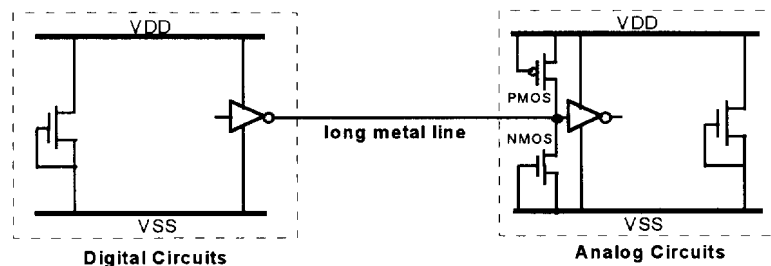
Fig.6 The proposed ESD protection method to rescue the ESD damage between the digital-analog interface.

To overcome this internal gate-oxide damage between the digital-analog interfaces, a new ESD protection circuit is added near to the input gates of the analog inverter as shown in Fig.6. The added ESD protection circuit is made by a PMOS and an NMOS devices with their gates shorted to their sources, respectively. The same ESD protection circuit is also added to the digital inverter with input signal from the analog part to avoid similar ESD damage. The device dimensions of ESD-protection PMOS and NMOS devices are designed under different lengths of the metal line, which is connected between the digital and analog circuits. An empirical design rule for device dimension of this internal ESD-protection device under different metal-line lengths is summarized in Table I. Following this design rule to add the ESD-protection devices on the long metal line between the digital-analog interfaces, the mixed-mode IC can be rescued to pass 2-KV ESD stress from the digital/analog VDD to digital/analog VSS pads without causing any internal damage.

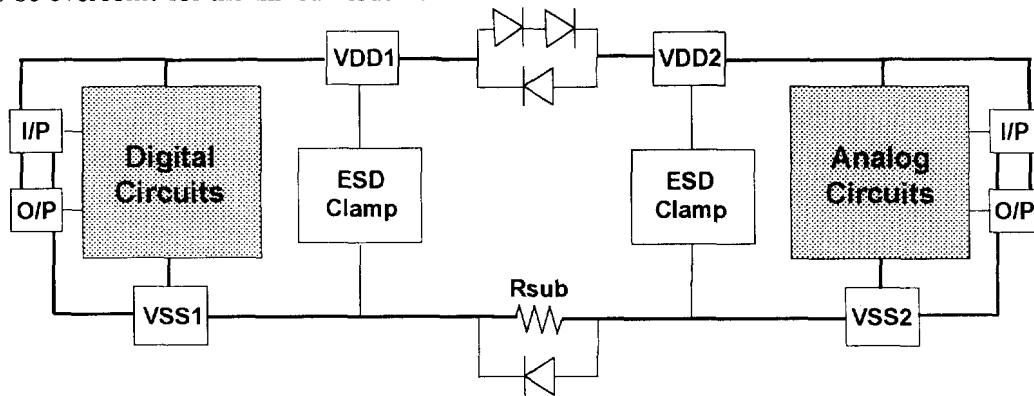
Fig.7 A schematic diagram to show the whole-chip ESD protection design for a mixed-mode IC.

Another solution to avoid such internal ESD damages is to consider the whole-chip ESD protection design. Especially in the mixed-mode IC with multiple VDD and VSS power pins. A schematic diagram to show a whole-chip ESD protection design for a mixed-mode IC is illustrated in Fig. 7. By using this alternative solution, the unexpected internal ESD damage can also be overcome for the mixed-mode IC.
